# Manhole Inspection Summary

Manhole # S51AA\_036MH

Insp Date: **3/5/10 1:59 PM**

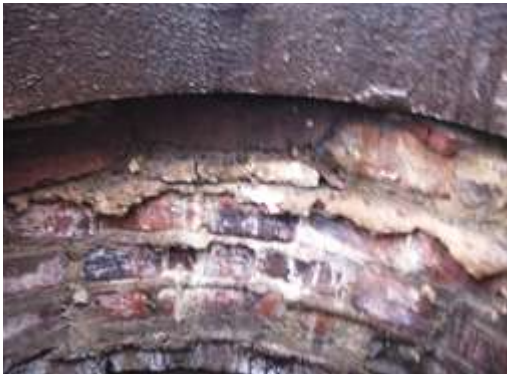
Defect 3

frame leaks

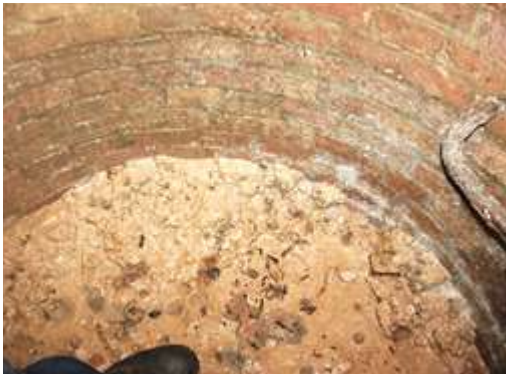
Defect 2

debris

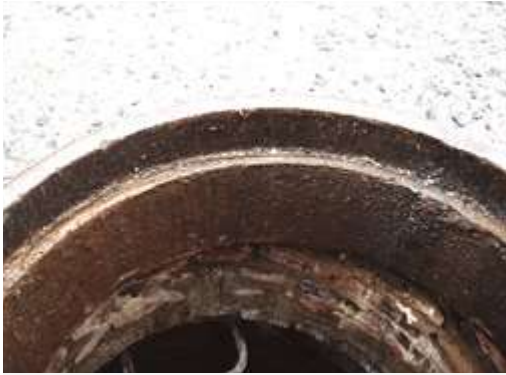
### Defect 1

frame leaks

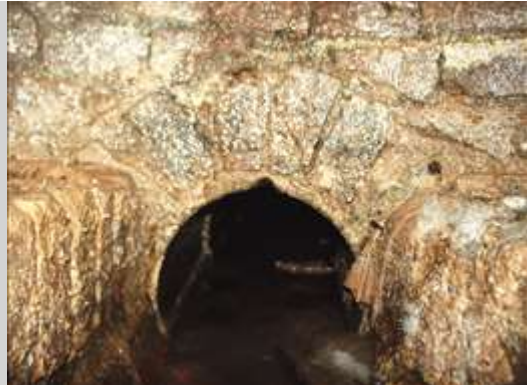
12 O'Clock Outflow

8 in. Circular Gravity Sewer  
Pipe Out @ 12 O'Clock

Pipe Height: **12** (in.) Rod and Bar (Angled)  
Pipe Material: **Clay** ☐ Pipe Lined  
Invert Depth: **9.08** (ft.) Flow Characteristics: **Fast**  
Deposits: ☒ None ☐ Mud ☐ Sludge ☐ Debris ☐ Grease  
Silt Depth: (in.) Deposits Extent:  
Infiltration: **None** Pipe Seal Cond: **Sound**

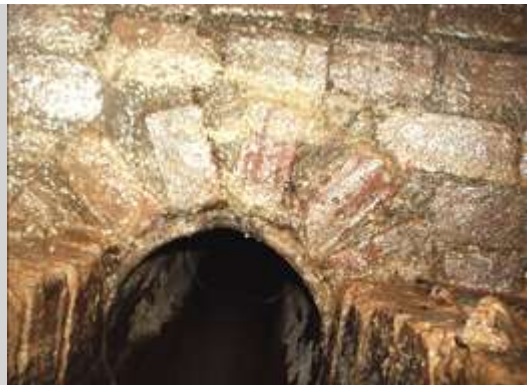
3 O'Clock Inflow

8 in. Circular Gravity Sewer  
Pipe In @ 3 O'Clock

Pipe Height: **12** (in.) Rod and Bar (Angled)  
Pipe Material: **Clay** ☐ Pipe Lined  
Invert Depth: **8.92** (ft.) Flow Characteristics: **Fast**  
Deposits: ☒ None ☐ Mud ☐ Sludge ☐ Debris ☐ Grease  
Silt Depth: (in.) Deposits Extent:  
Infiltration: **None** Pipe Seal Cond: **Sound**
